Excalibur Shield MIC Case Study

In this case study, the Excalibur Shield was employed to monitor MIC and weight loss at a worst case scenario on a 20-mile long, 10" carbon steel condensate pipeline operating at 700 PSI.

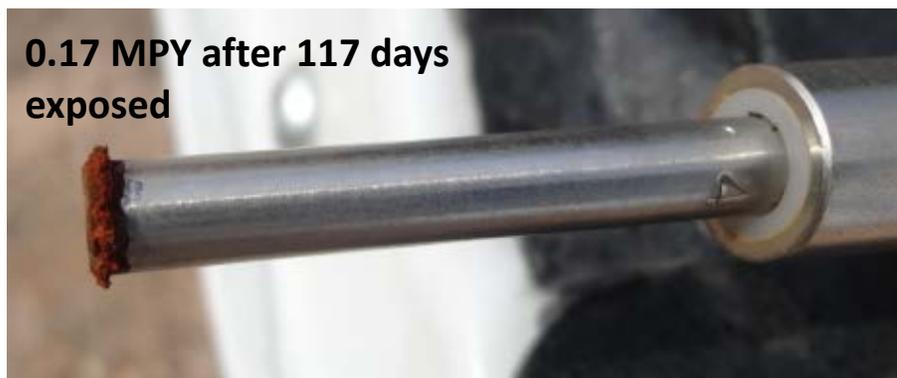
Fig 3

The only effective analysis was the retriever style coupon (Figure 3). Depicted on Figure 3, the pre-weighted coupon with 2" x ¼" diameter was installed and exposed to the internal environment for period of 117-days, and resulted in a 0.17 MPY. The corrosion rate of a coupon is expressed in mils per year (MPY), or millimeters per year, or number of one-thousandths of an inch of metal lost from a coupon surface over a 1-year period. Average corrosion and pitting (localized corrosion) rates obtained from a coupon are categorized as low, moderate, high, and severe in accordance with classifications in NACE SP0775-2013, shown in Table 1. Ideally this style of coupon is inserted from 12 o'clock and lowered to near the 6 o'clock position in a horizontal pipeline. The placement of the coupon is often the most critical decision in obtaining meaningful internal corrosion information. Upon closer inspection, only the very end of the coupon was being exposed to the worst area inside the horizontal pipeline.

After 30-days exposure to the internal environment, the Excalibur Shield registered a 1.28 (MPY) at six o'clock, compared to the 0.17 (MPY) on the previous 117-day exposure using the retriever coupon (Figure 3), mincing a low lying area of worst case scenario. Now the operator

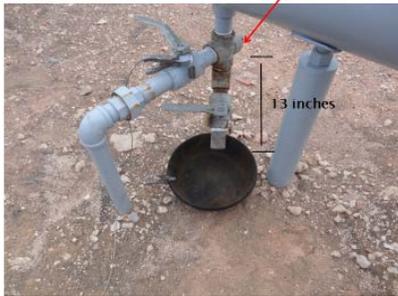
Fig 4

New devices added to existing infrastructure

The Excalibur Shield was easily installed using the existing infrastructure, and no welding was required. The existing sump tank drainage piping system (Figure 4) was also used to install additional fittings to accommodate for the Excalibur Shield (Figure 5). The Excalibur Shield can be installed with a minimum clearance of 13". After installation, the owner operator had the capability of acquiring solids, liquids, and weight lost coupon at the worst case scenario.

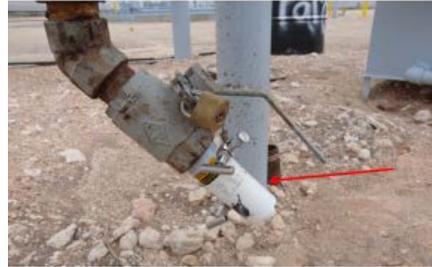
Fig 5

Excalibur Shield Installed

The Excalibur Shield has a primary filtering system at the mouth of the 100 ml cavity. A coupon was installed inside the cavity with a secondary filter system surrounding the coupon. The outer portion has an octagon shape for easy removal including drain and ventilation valves for easy collection of fluids inside the cavity. The base adapter is outfitted with an O-ring seal for easy removal and secure sealing capability using a 316-L stainless steel body, mop 2000 PSI (Figure 5).

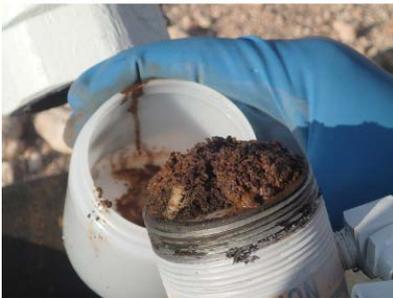
Fig 6

Solids above primary Filter

Acid producing bacteria (APB) and sulfate reducing bacteria (SRB) tests measured very low. In addition, we now have the capability of acquiring fresh solids (fig. 6) and liquid samples, (fig. 8).

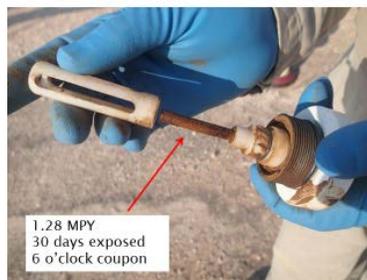
Fig 7

First pull 30 day exposure

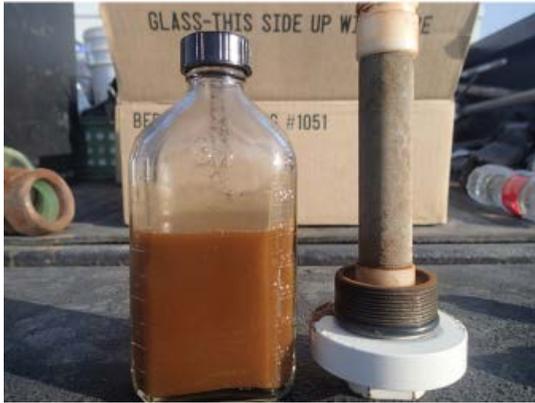
Fig 8

100 mls. brownish water

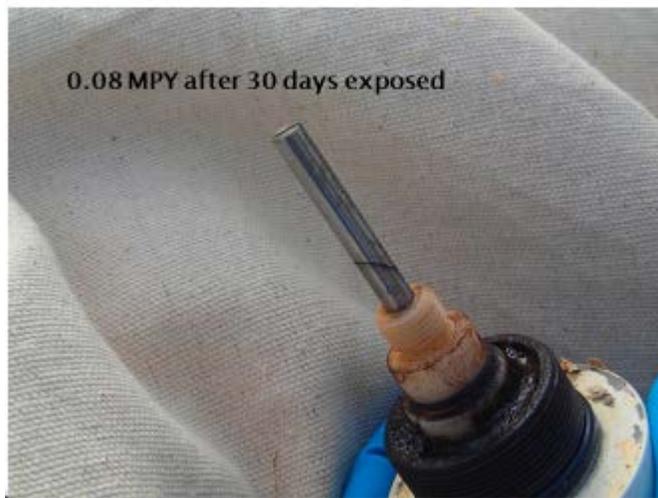
Figure 9.

After a second 30-day exposure and optimizing the inhibitor treatment with the Excalibur Shield resulted in a 0.08 MPY (Figure 9).

After optimization

Second pull, increased inhibitor quantities
